Almondsbury Clock

Gerry Anniss, Almondsbury

Part 1 - Clock restoration

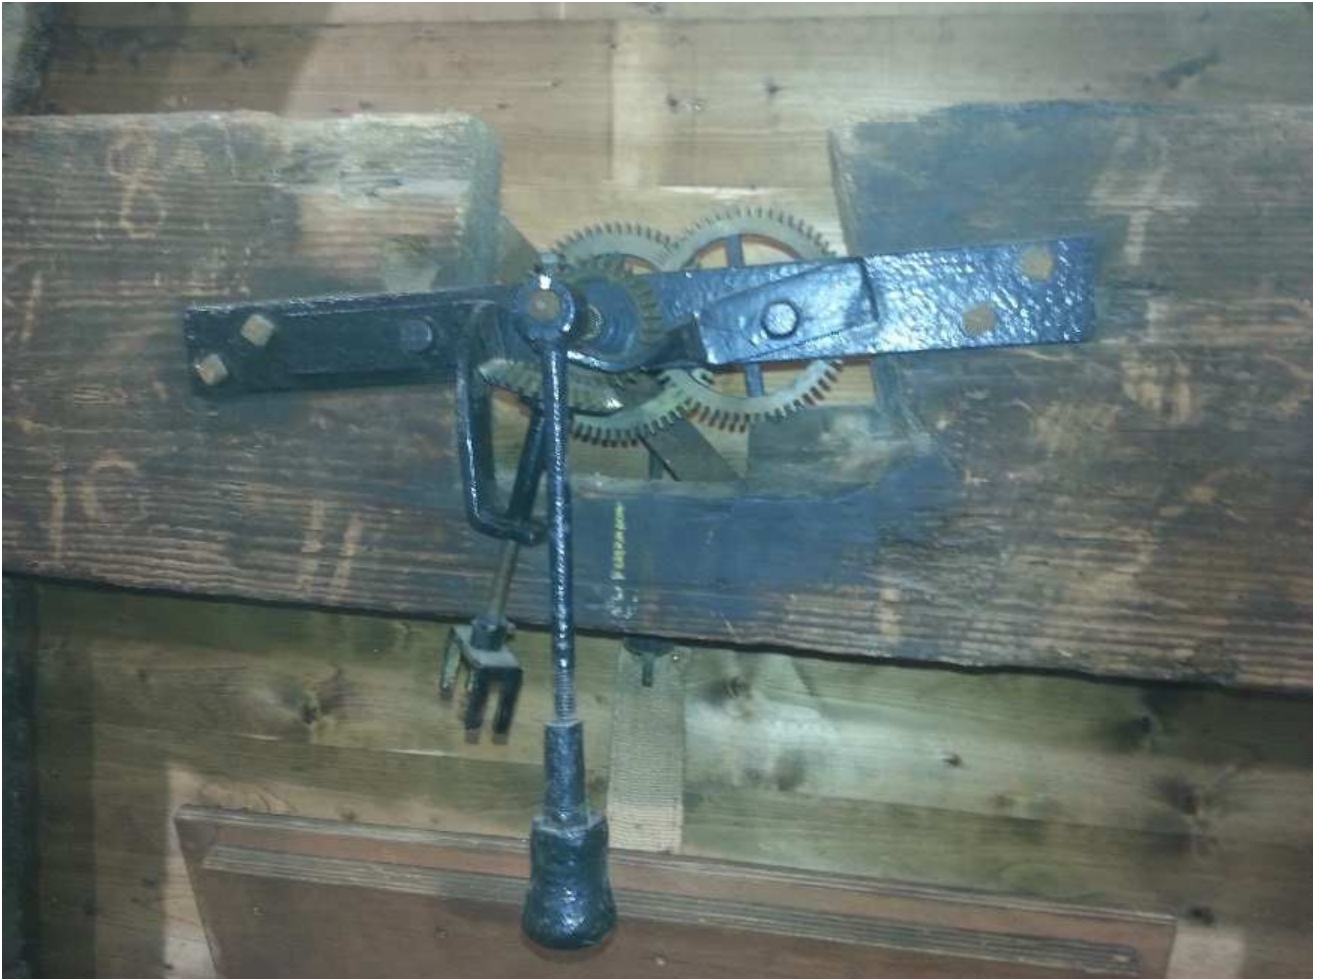
Problems with the clock had been dragging on since the summer of 2019. The clock kept stopping. It would run for a few days then stop. Days became hours then minutes. In the end we realised that the clock itself was fine but the drive to the hands was at fault but couldn't pin down exactly where.

The picture below shows the motion works in-situ inside the belfry at the back of the clock face. The counterbalance for the minute hand is the long rod with the lump at the end. The pronged thing to its left is the disconnected drive from the clock in the ringing room below.

This is the most neglected part of the clock mechanism according to the Bath & Wells DAC clock expert.

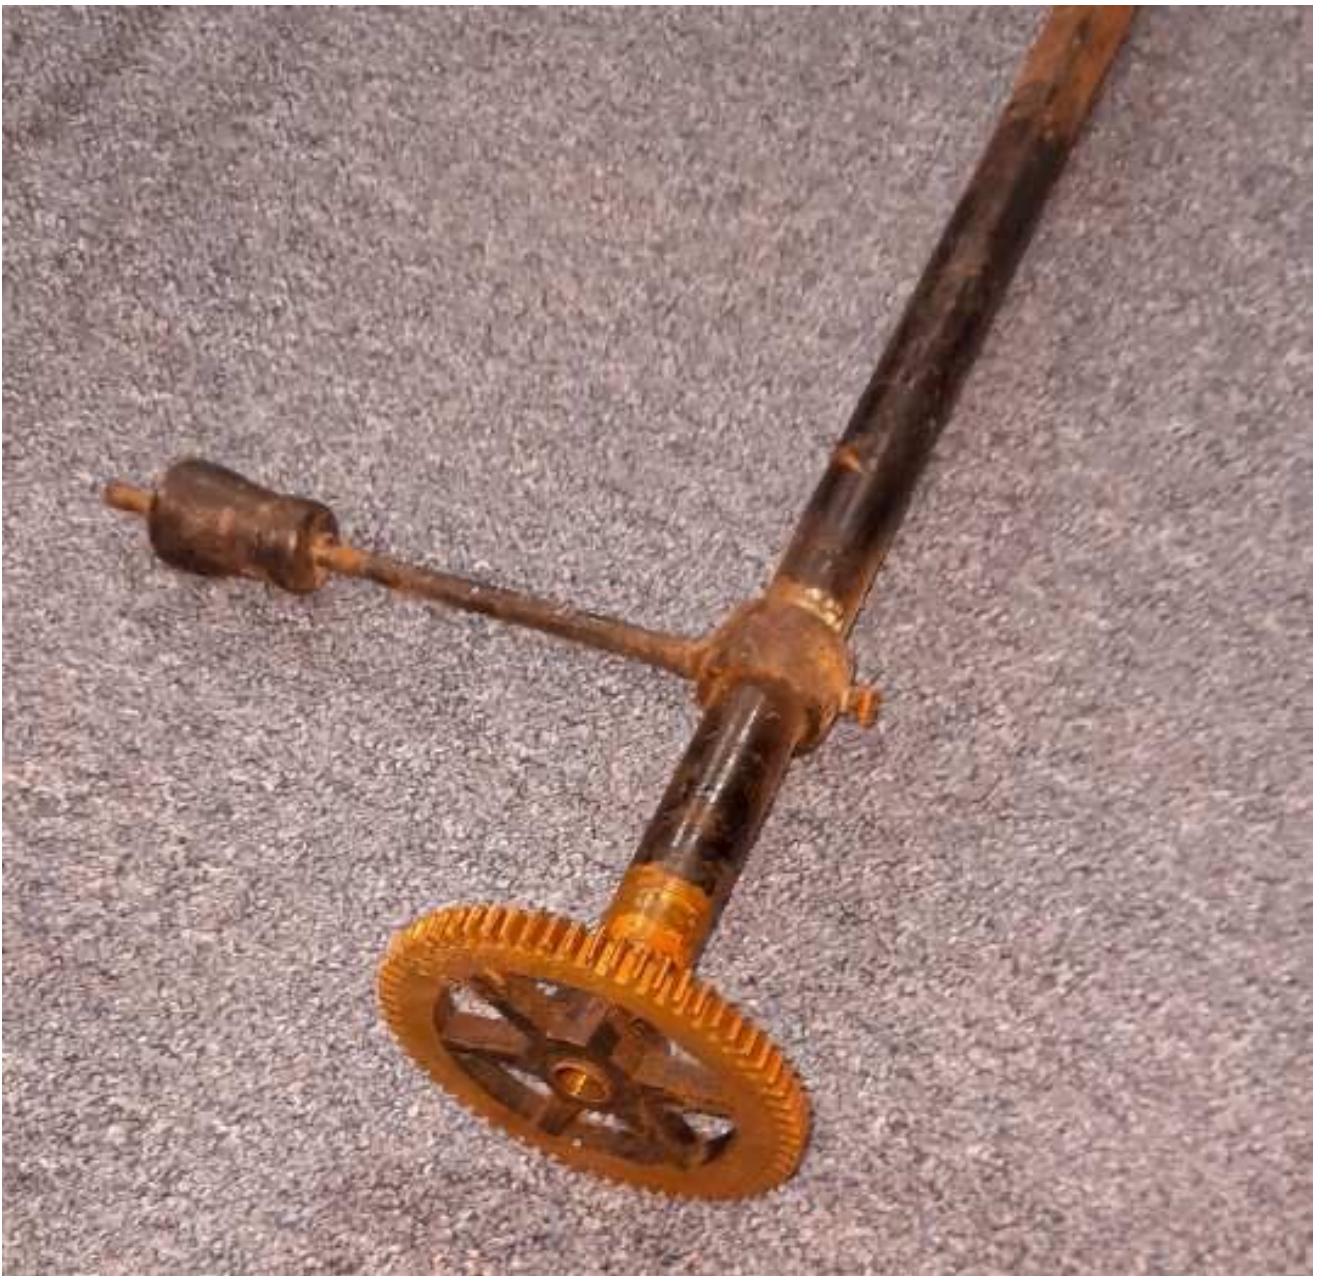
Picture above shows the hour tube with pinion (gear) wheel and hour hand counterbalance.

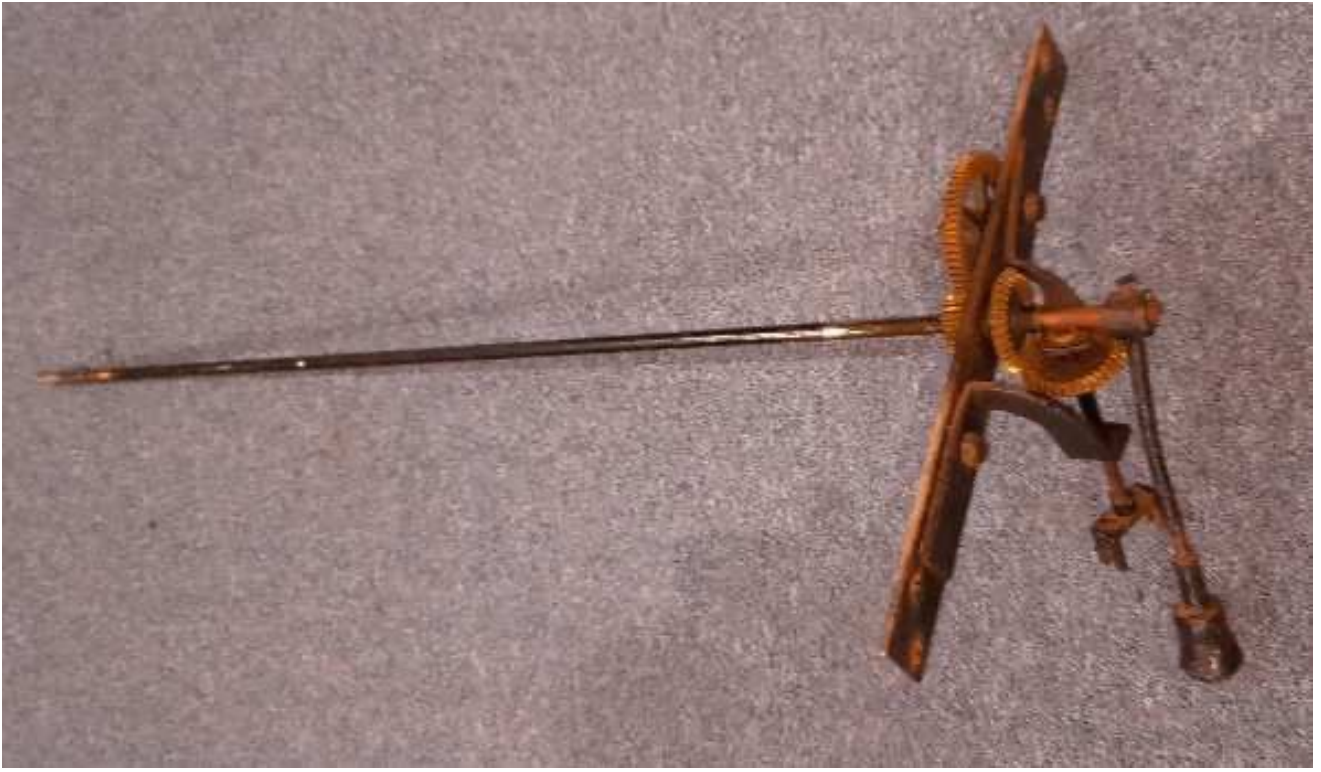
Picture below shows minute hand arbor rod with mounting bracket.

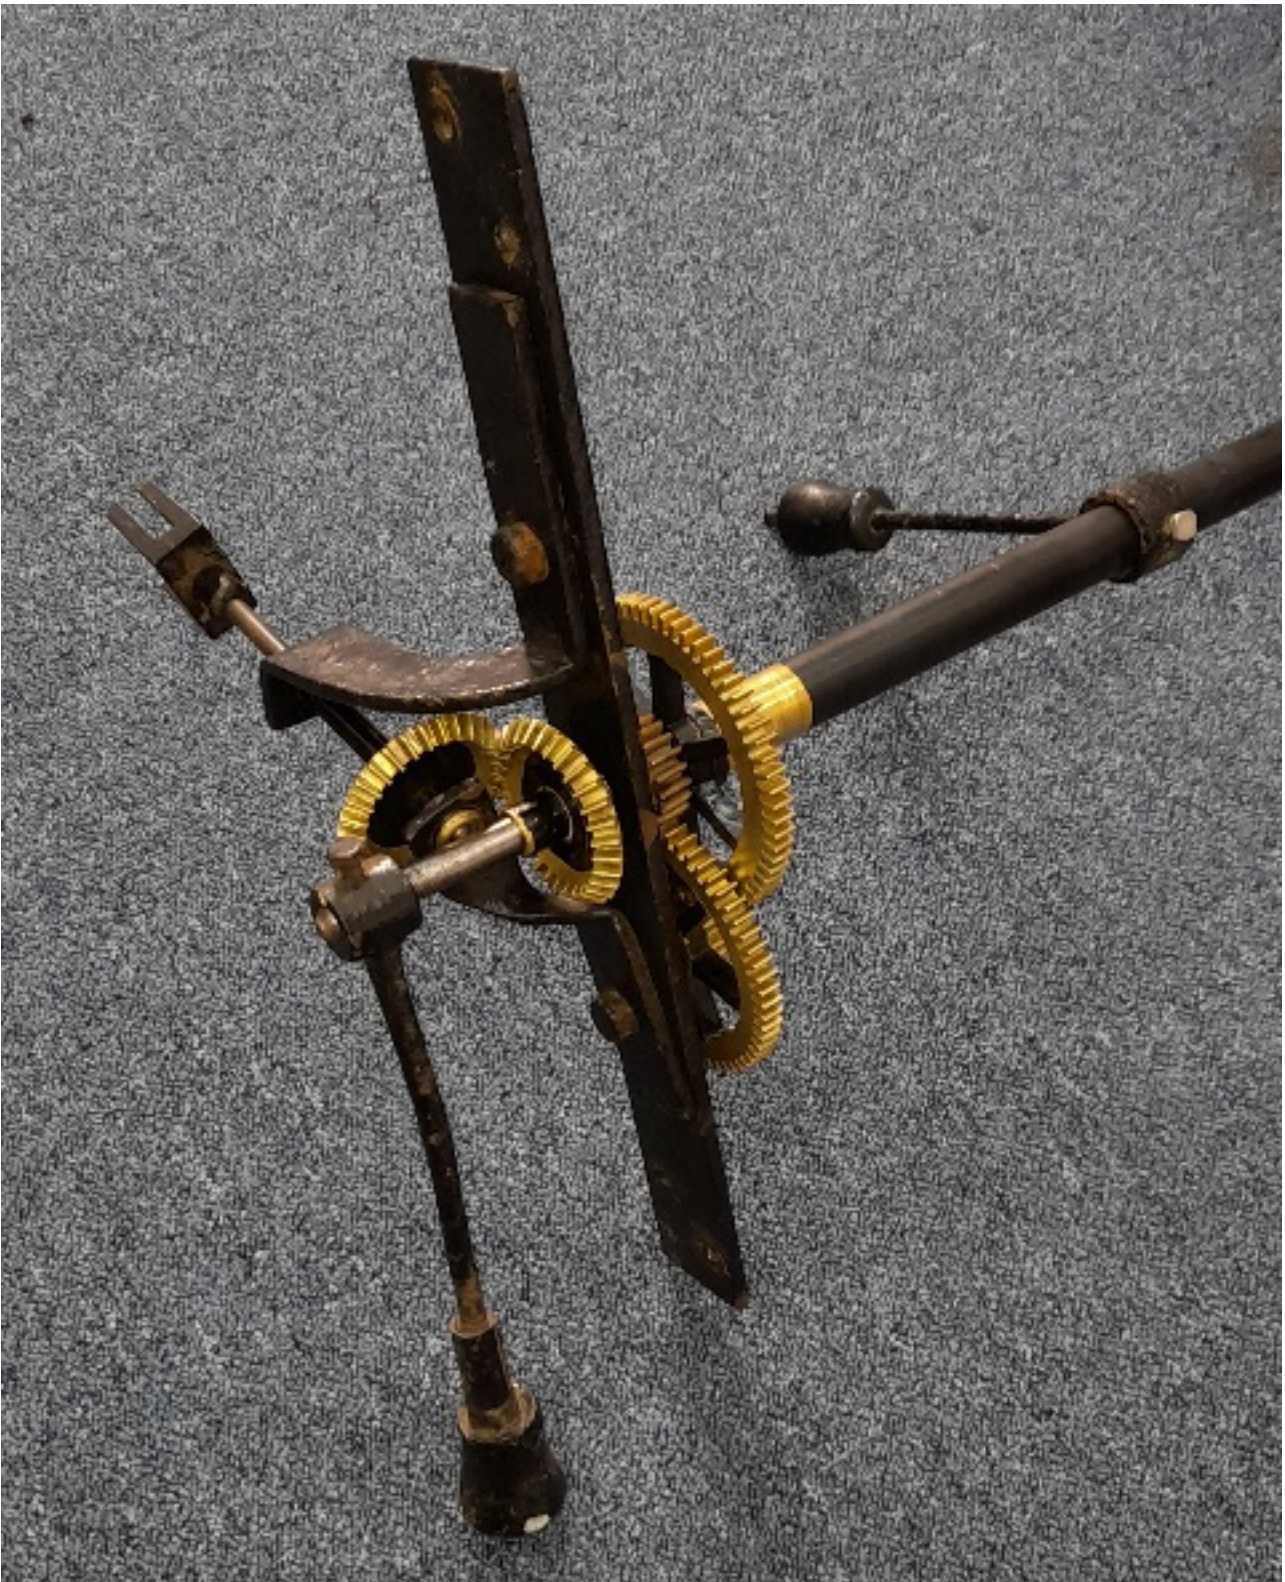
The picture below shows the restored motion works assembled and ready to be installed behind the clockface. The counterbalance weight for the minute hand is the long black rod with the lump on the end dropping down in the foreground. The pronged thing to its left is the connector for the drive from the clock in the ringing room. The other shorter rod further along the black tube with the lump on the end is the hour hand counterbalance weight.

Once the hour tube and minute arbor rod assembly were reinstalled the hands could be fitted back onto the face of the clock. As soon as the green light of approval from the authorities was given, Symon Boyd of Timsbury Clocks wasted no time in taking the parts away, doing what was necessary to clean, repair, restore, paint and bring them back, to enable the hands to be on the clockface once more.

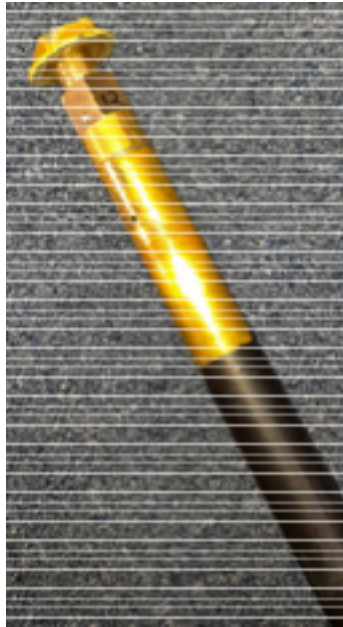
The picture below shows the other end of the motion works with the square end of the hour tube to which the hour hand will be fitted and the smaller diameter rod of the minute arbor rod protruding through it, to which the minute hand will be secured by the threaded locking disc shown on the end.

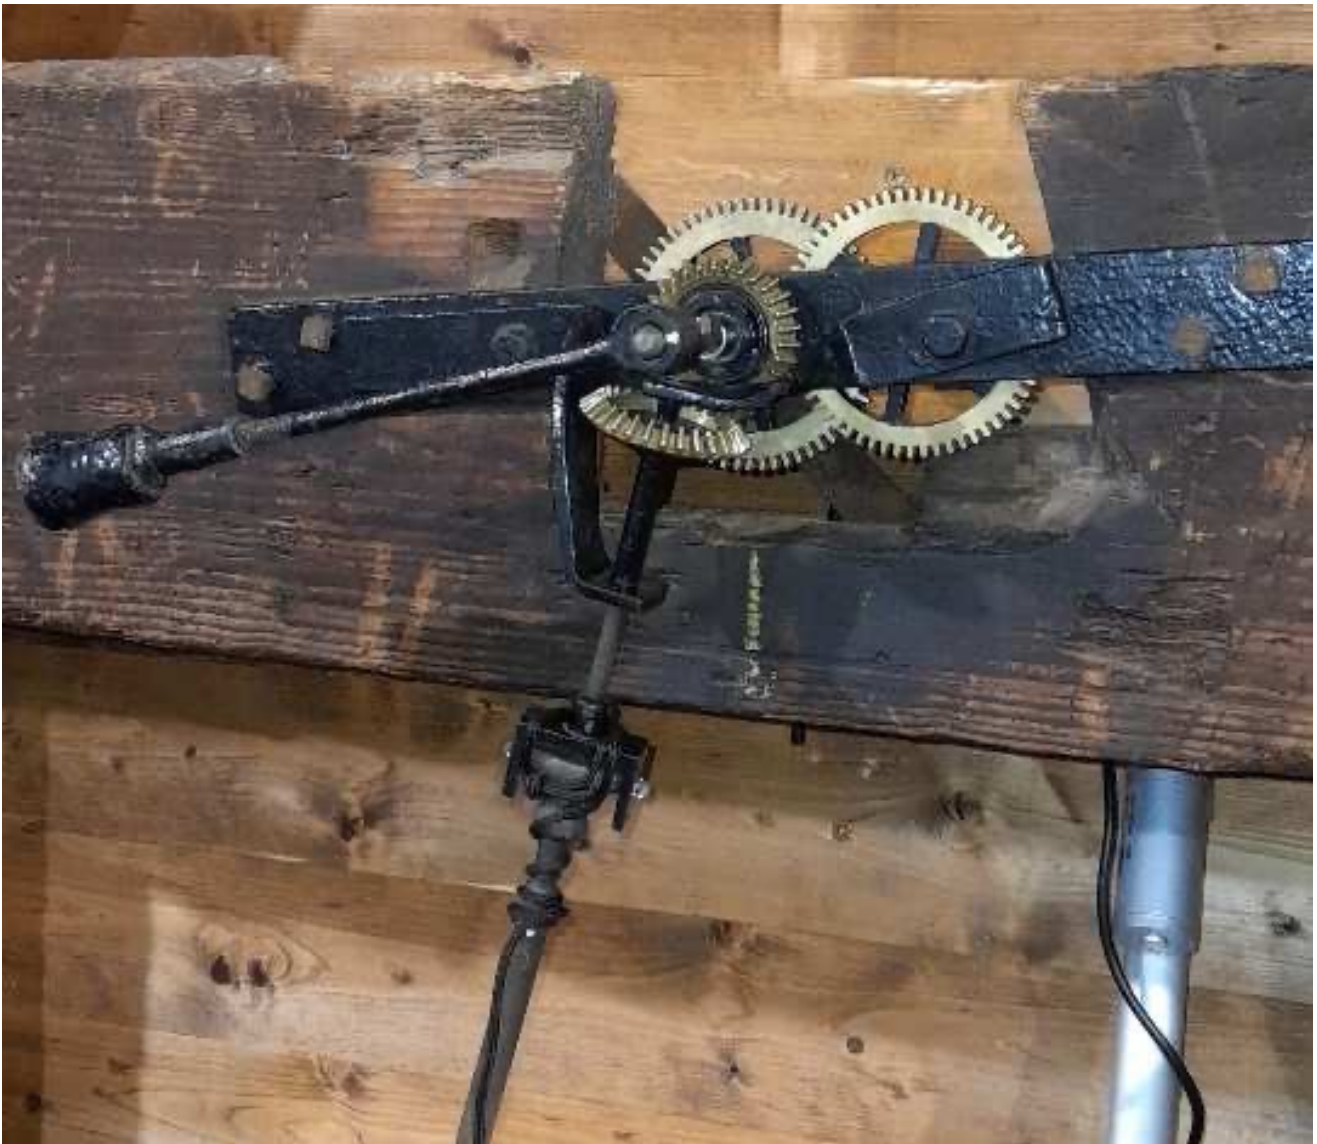
The picture on the left shows the motion works in situ with drive shaft connected coming up from the clock at the bottom, the minute hand counterbalance pointing to the left. The hour hand counterbalance is obscured by the old timber support.

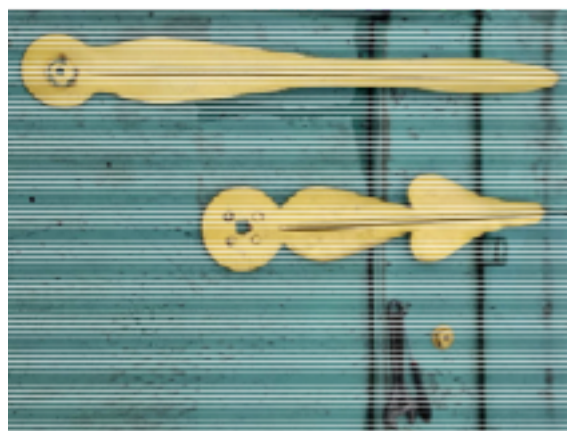
The picture below shows the hour and minute hands waiting to be fitted. These are made of copper and gilded with 24 carat gold leaf to withstand the weather. The overall length's are 850 and 570mm respectively.

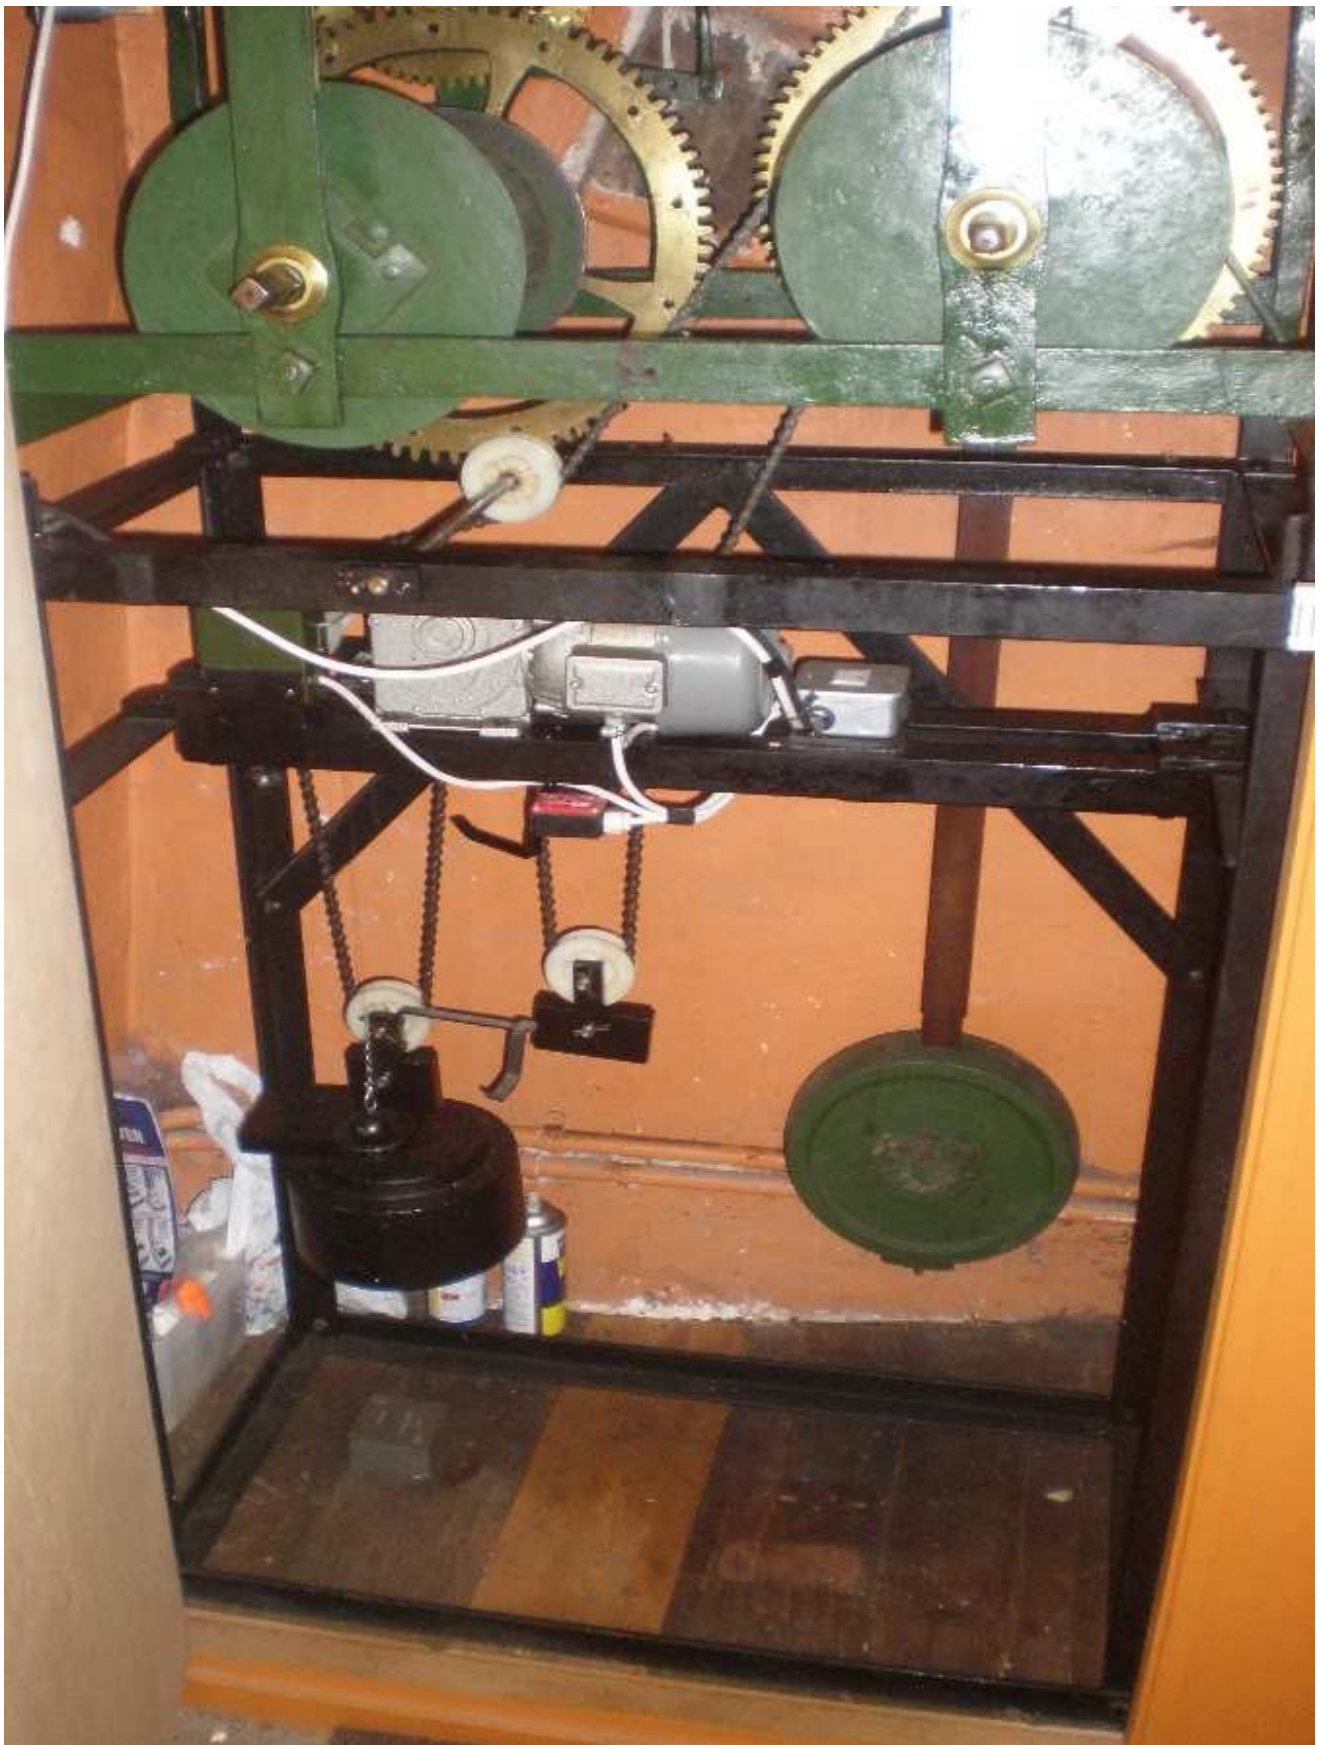
The bevel gear indicated above has 2 grub screws. One of them has stripped its thread in the bevel gear boss and is not holding. The other is about to fail and cannot be fully tightened to secure the bevel gear to the shaft. This means that from time to time the dial minute hand on the clock face gets out of synch with the clock movement which tends to show the clock as running a few minutes slow even though it strikes the hour on time. This can be caused by strong gusts of wind slowing down the large minute and hour hands on the North facing clock dial also when the clock is adjusted for timekeeping.

The proposal is to remove the lead-off bracket along with the faulty bevel gear from the clock movement. This will entail disconnecting the lead-off drive rod from the constant velocity joint and removing the bevel gear, its shaft, along with the bracket assembly to the horologist's workshop where the bevel gear boss will be machined to remove the grub screws and stripped threads and to machine and fit a fixed pin through the boss and shaft. The bracket will then be refitted to the clock movement with the modified bevel gear and its shaft. The clock will be adjusted and checked to ensure that the movement is running correctly. This work will secure the bevel gear directly to the shaft and remove any future slippage through this part of the mechanism.
